PUTNAM PEAK AND VICINITY, ENCLISH HILLS

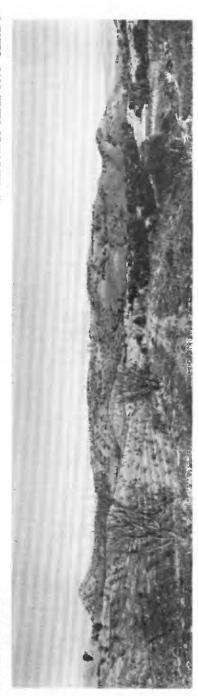
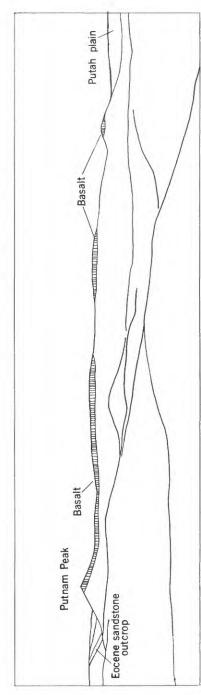
Panoramic view and sketch, looking north and east. Most of the area is poorly exposed sandstone and shale; basalt caps the ridge along the skyline. (See also geologic section D.D., fig. 7.) Photograph by F. H. Olmsted

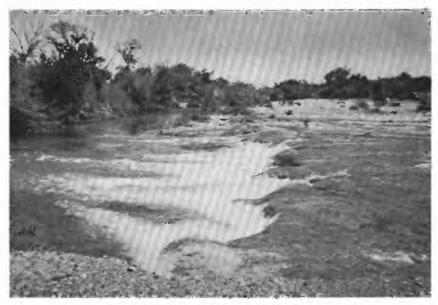
A. PUTAH CREEK CHANNEL DOWNSTREAM FROM RIVER MILE 16.8

Channel downstream is 3-5 feet lower than bed above falls. Falls formed by tough clayey silt into which creek is cutting from Winters downstream to mouth. Photograph by H. G. Thomasson.

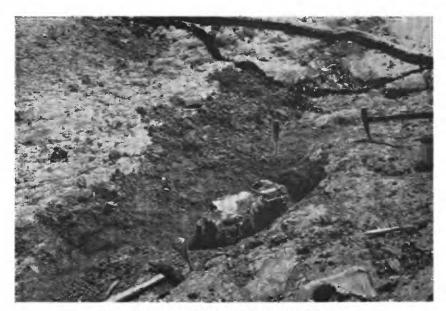
B. FOSSIL IN BED OF PUTAH CREEK AT RIVER MILE 13.0

Humerus of Paramylodon cf. P. harlani (Owen). One of several vertebrate remains found in the stream bed between river miles 12 and 15. Photograph by J. E. Upson.

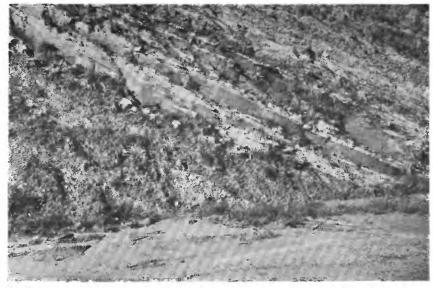
A. EXPOSURE OF TEHAMA FORMATION EAST OF VACAVILLE

Two conglomerate beds and intervening well-bedded sandstone exposed in the cut on the northwest side of U. S. Highway 40 about 1 mile east of Vacaville. Photograph by F. H. Olmsted.

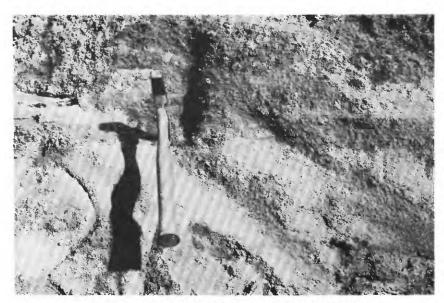
B. PUMICEOUS TUFF IN LOWER PART OF TEHAMA FORMATION

Exposed in roadcut in 9/2W-36F. Fluviatile or deltaic deposition indicated by crossbedding. Note large size of some pumice fragments near top of picture. Photograph by F. H. Olmsted.

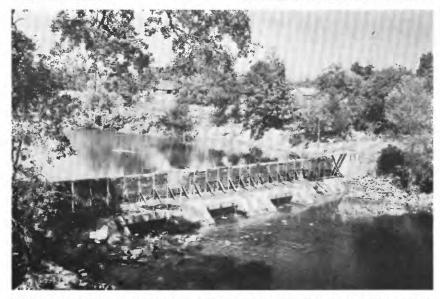
A. Flashboards in place form temporary pool about 10 feet deep. Purpose of dam is to increase groundwater recharge in late spring after the danger of floods has passed.

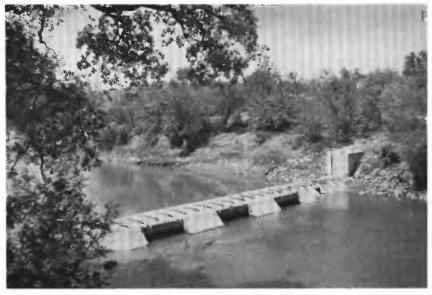
B. Flashboards removed and tunnels open throughout winter runoff season. Photograph by H. G. Thomasson.
FLASHBOARD DAM ON PUTAH CREEK AT WINTERS
